MH17 Brought Down by Air-to-Air Missile, Finished Off by 30-mm Cannon, Experts Allege

By Ria Novosti

August 07, 2014

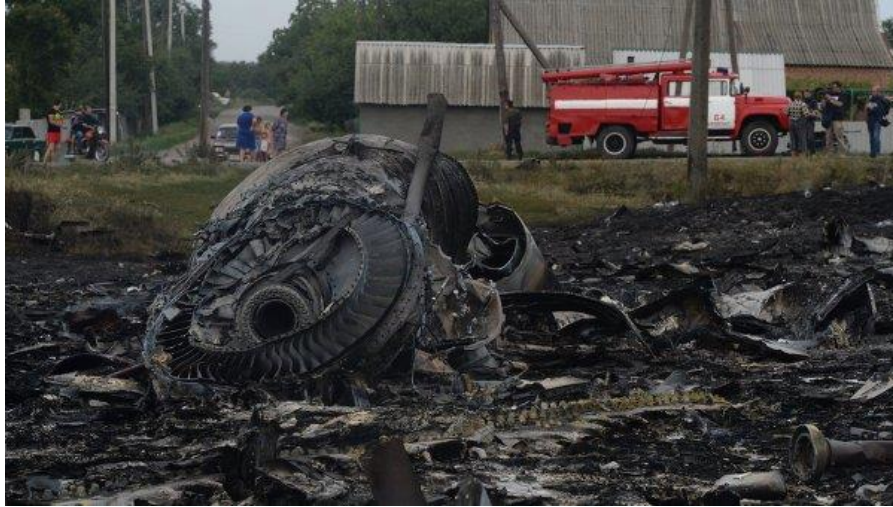
Malaysian Boeing crashes in Ukraine

According to the experts, if this hypothesis is true, it would explain the bullet holes in some sections of MH17’s fuselage.

“Some showed blast patterns consistent with shrapnel from a proximity-fused weapon while some showed the more precise grouping consistent with that of cannon fire. We’re analyzing this,” said one of the sources, adding that a detailed analysis of the pieces of the jetliner is needed to corroborate this emerging theory.
